National Highway  
Traffic Safety  
Administration

# **Technical Assessment of Toyota Electronic Throttle Control (ETC) Systems**

**February 2011**

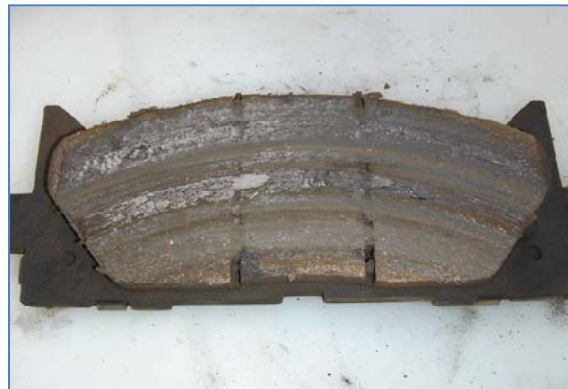
Brake fade is a reduction in braking effectiveness or stopping power that occurs due to friction-related thermal effects of repeated and/or sustained brake application, especially in high-speed conditions. Post-incident inspections of brake components removed from vehicles involved in high-speed, long-duration incidents have revealed evidence of this type of thermal degradation of friction materials indicative of prolonged braking at speed (Figures 4 and 5). This type of damage has only been observed in incidents that originated at highway speeds and involved prolonged open-throttle braking.<sup>45</sup> These types of events were first observed by NHTSA in 2006 in MY 2007 Lexus ES 350 vehicles<sup>46</sup> and, to date, such brake system overheating in UA incidents has only been observed in events involving throttles stuck wide-open due to pedal entrapment.

**Figure 4: Left-front inboard brake pad; 2007 Lexus ES350 (ODI 10182245)**

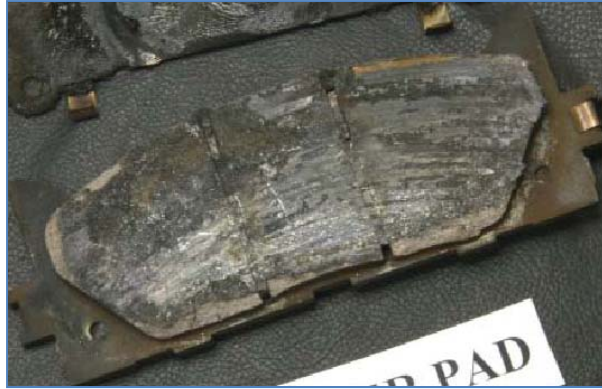
**Figure 5: Left-front inboard brake pad; 2009 Lexus ES350 (ODI 10284881)**
