National Highway  
Traffic Safety  
Administration

# **Technical Assessment of Toyota Electronic Throttle Control (ETC) Systems**

**February 2011**

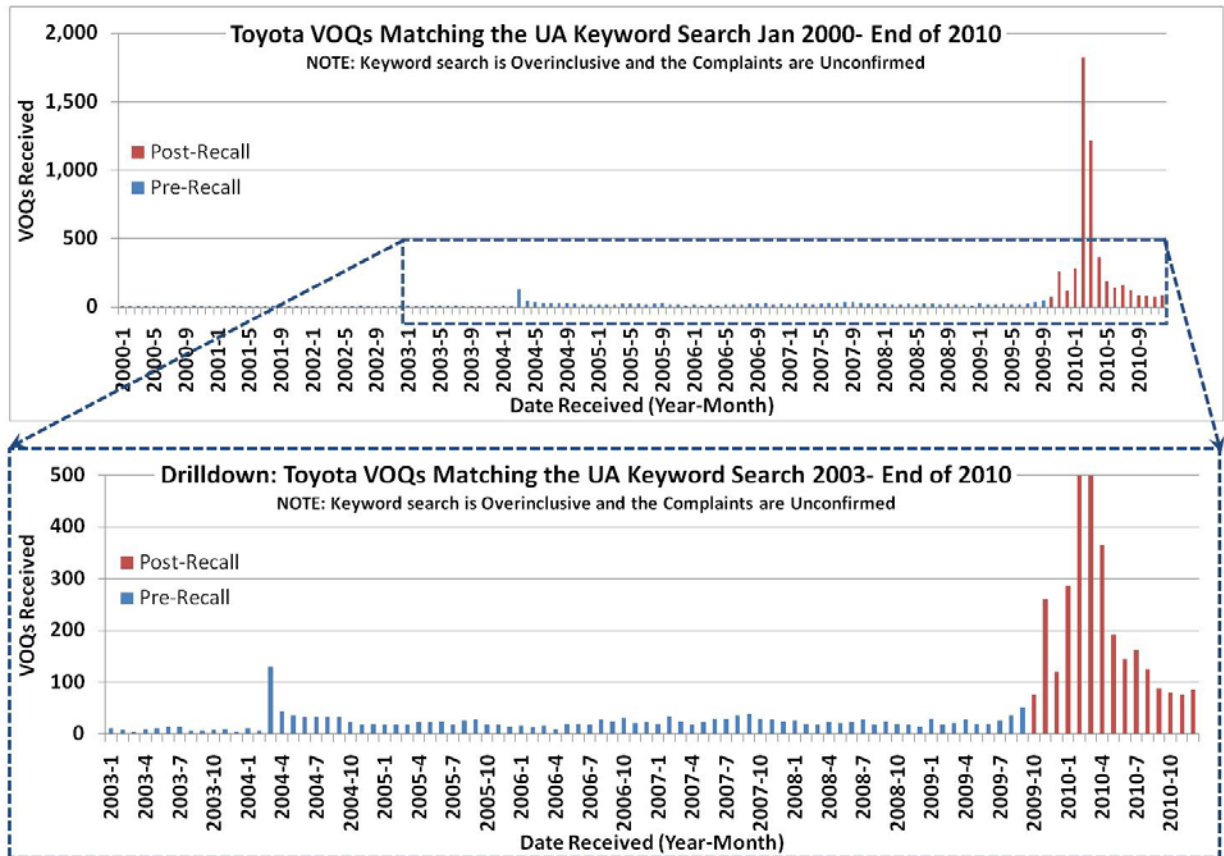
**Figure 1: Consumer Complaints to NHTSA Alleging Unintended Acceleration in MY 1998-2010 Toyota Vehicles**

For example, NHTSA's complaint volume spiked in March 2004, (after four months of pre-investigative screening of the problem) when NHTSA opened an investigation (PE04-021) of electronic throttle control concerns in the 2002-2003 Camry, Solara, and ES300 (Figure 1). However, it is unlikely that this spike was caused by a sudden increase of the in-field failures at that time. Rather, the spike was likely related to publicity surrounding the opening of the investigation. Complaints also ramped up starting in September 2009, through the end of March 2010. Publicized events during this time period included the fatal ES350 crash near San Diego, California in late August of 2009, announcement of a safety recall involving the accelerator pedal being entrapped by out of position floor mats (Safety Recall 09V388) in early October, an expansion of the October recall and announcement of a new recall for a "sticky pedal" defect in January 2010, and the early 2010 Congressional hearings. A majority (71%) of the complaints presented in Figure 1 were reported after the announcement of the pedal entrapment recall in October 2009, with almost half (43%) received in the months of February and March 2010.<sup>39</sup>

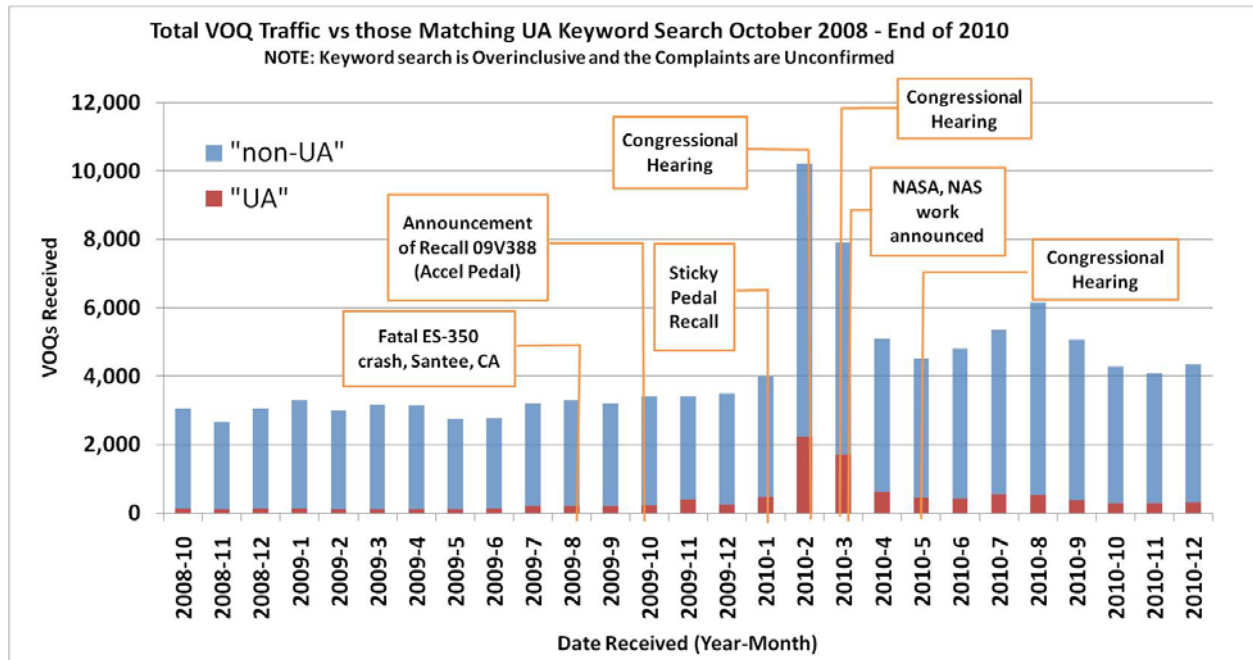
**Figure 2: Recent VOQ Traffic to NHTSA – UA vs. Non-UA**

Although the proportion of complaints concerning UA allegations rose considerably, the publicity surrounding certain events substantially increased the flow of complaints to NHTSA in all categories, not just UA, as Figure 2 illustrates. Although Toyota vehicles accounted for a disproportionate share of the influx of complaints, complaint volumes on vehicles of all major manufacturers were affected.

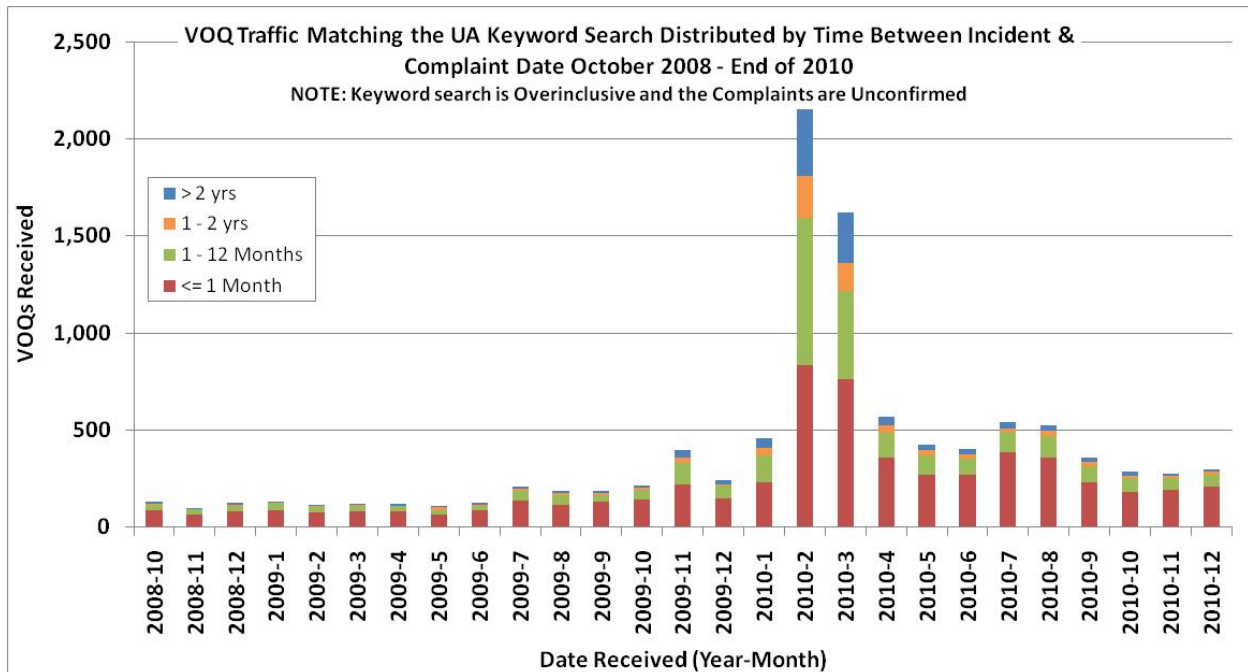
**Figure 3: Recent UA VOQ Traffic to NHTSA – Older Incidents vs. New Incidents**

The time lag between incidents and complaints about them is also affected by publicity. Throughout the past decade, a majority (64%) of complaints (UA and non-UA) were filed within a month of the incident's occurrence. In contrast, during the heightened publicity in early 2010, complaints pertaining to recent UA incidents were less than half of the total (42%), and a quarter (26%) of UA complaints filed pertained to incidents over a year old. This time lag suggests that a major portion of the increased complaints was the reporting of older incidents rather than an uptick in new incidents (Figure 3).

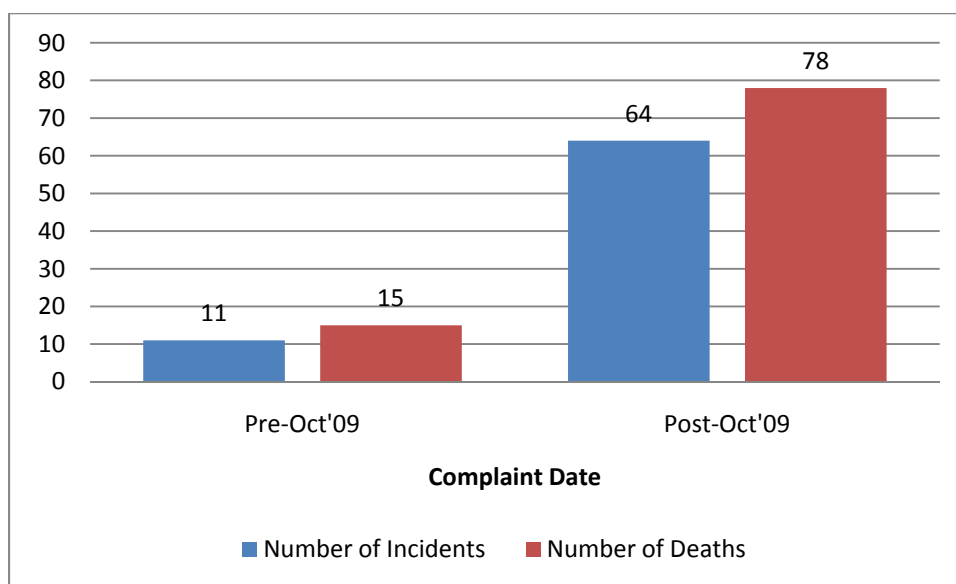
**Figure 6: Fatal Incidents by Complaint Date**

Publicity has affected the reporting of these incidents to NHTSA. The Toyota pedal entrapment recall was announced in October 2009, which provides a useful point of reference. Figure 6 shows fatal incidents by complaint date. Eighty-five percent of the incidents (64 out of 75) have been reported to NHTSA since October 2009. In fact, 58 of the incidents (77%) have been

reported just since the “sticky pedal” recall in late January 2010, which intensified public interest. The most incidents were reported in February and March of 2010, with 22 and 24 respectively. The latest incident was reported in June 2010. Although a significant time lag between an incident and the submission of a complaint does not diminish the complaint’s credibility, these numbers strongly suggest that publicity played a major role in the reporting of these incidents. Of the 11 incidents that were reported before October 2009, 10 involved vehicles with ETC. Of those 10, half (5) were reported during the 3-month publicity spike after the original investigation of ETC was opened early in 2004.

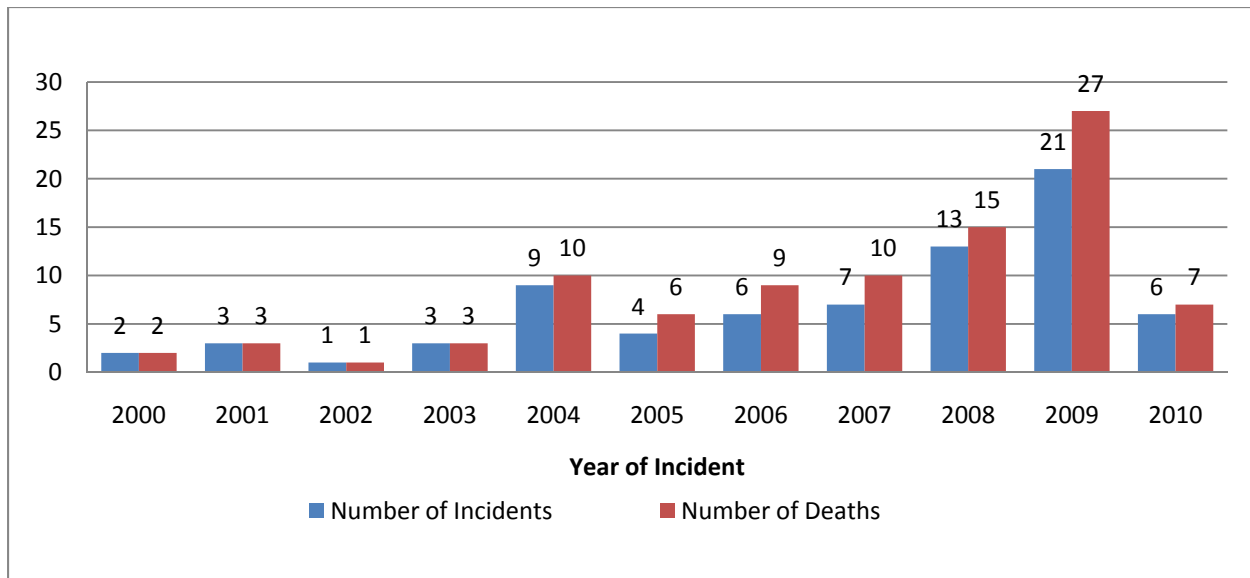
**Figure 7: Fatal Incidents by Incident Date**

Even though most of these incidents were reported to NHTSA in 2010, very few of them actually occurred in 2010. Only six of the reported incidents (involving seven deaths) have occurred in 2010. Many of the occurrences were in 2009, but some of the recently received reports involve incidents dating back several years. Figure 7 shows fatal incidents by year of incident.
